**STRESS - CORROSION AND CORROSION - FATIGUE  
SUSCEPTIBILITY OF HIGH-STRENGTH  
ALUMINUM ALLOYS**

**G.E. NORDMARK, B.W. LIFKA, M.S. HUNTER,  
AND J.G. KAUFMAN**

**ALUMINUM COMPANY OF AMERICA  
ALCOA RESEARCH LABORATORIES  
NEW KENSINGTON, PA.**

**TECHNICAL REPORT AFML - TR - 70 - 259  
NOVEMBER 1970**

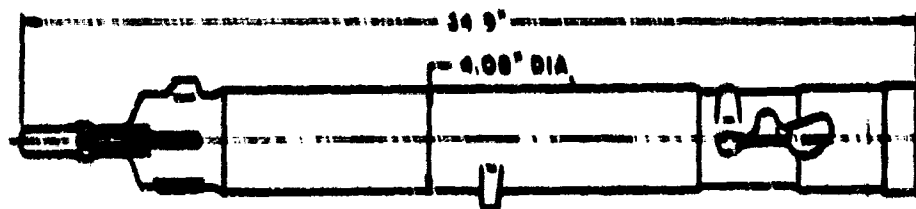
(a) ORIGINAL FORGING

b. Die forgings made at Alcoa's Cleveland Works from a portion of the 4-1/2-in. diameter stock described above. The shape selected (Fig. 1a) is a commercial die forging, normally made from 4-1/2-in. diameter stock. Its dimensions are such that the desired cylinder blanks (Fig. 1b) could be obtained with a minimum removal of parting-plane structure. The die forgings were ultrasonically inspected at Cleveland and found to meet standards for aircraft forgings.

The die forgings and rolled forging stock were machined to cylinder blanks, 2.3 in. I.D. by 4.08 in. O.D. by 18-in. (Fig. 1b) at Alcoa's New Kensington Works. These were heat treated and aged at the Alcoa Research Laboratories to the specified tempers in accordance with recommended practices.

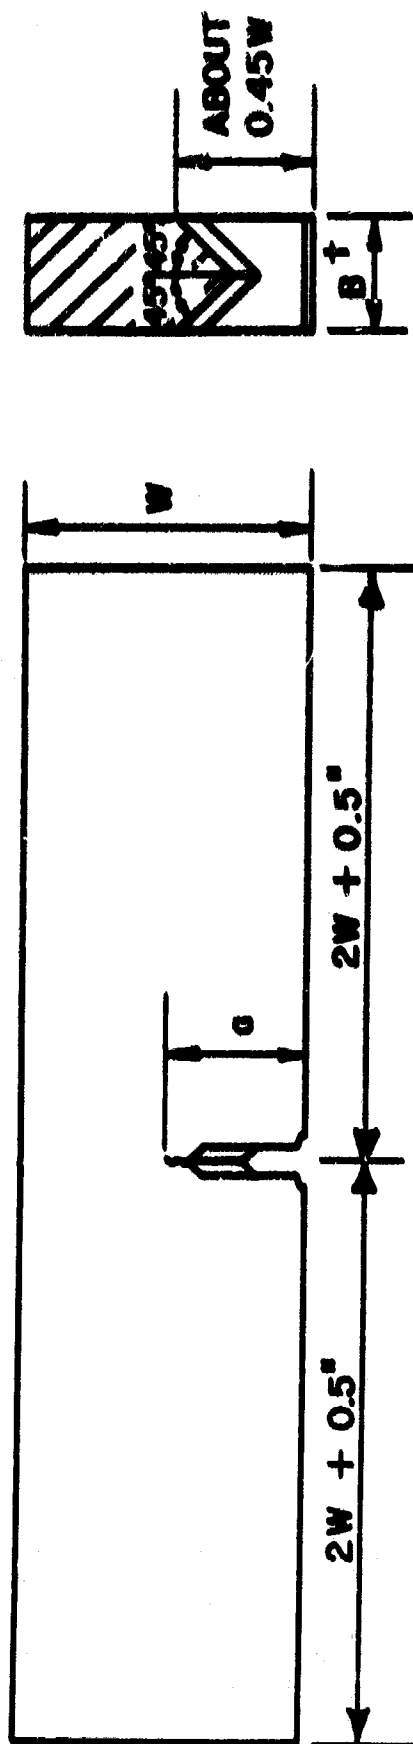
NOTCH - BEND FRACTURE TOUGHNESS SPECIMEN  
FIGURE 3

THICKNESS, B, IN.	WIDTH, W, IN.	LENGTH, IN.	CRACK LENGTH, $a_0$ *, IN.
W-L	1/4	1/2	3	1/4
L-W	3/4	1-1/2	7	3/4

\* INCLUDING AT LEAST 0.050 IN. OF FATIGUE CRACK

Longitudinal and transverse tensile, tear and fracture toughness specimens were taken from cylinder blanks; the transverse specimens were taken both across and 90° from the parting line. The tensile and fracture toughness specimens were prepared and tested in accordance with ASTM Standard Methods E8<sup>1</sup> and E399<sup>2</sup>, respectively. The tear specimens were tested as described in reference 3. The tear and fracture toughness specimens are shown in Figs. 2 - 4.

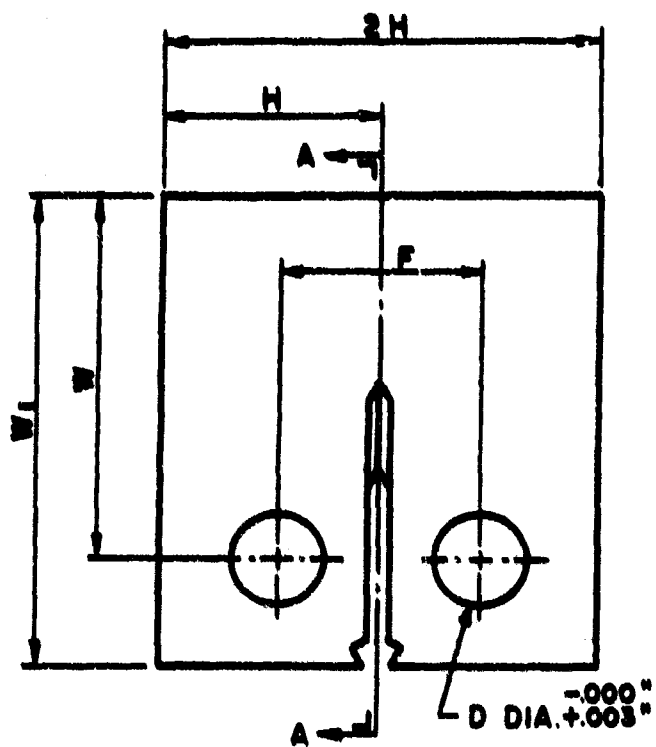
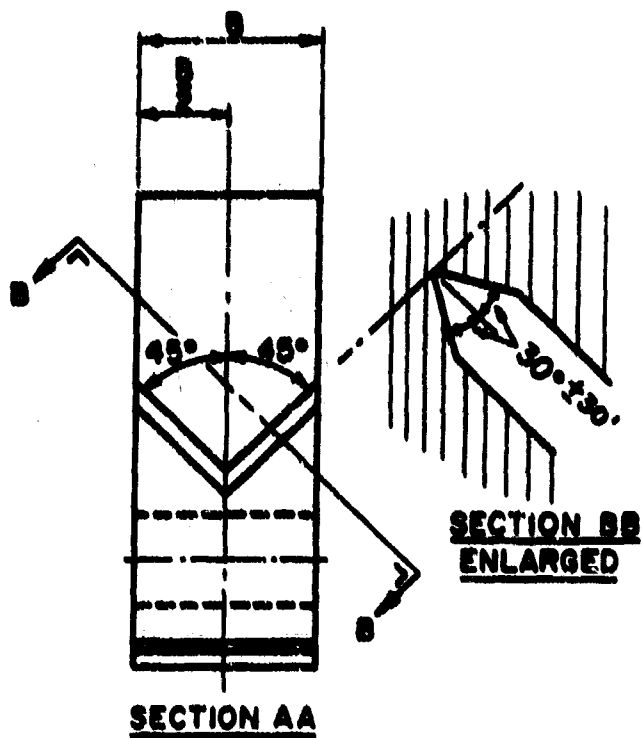
FIGURE 4

NOTCH ROOT  
RADIUS .010" MAX.

SPECIMEN  
ORIENTATION  
IN CYLINDER  
BLANK.

COMPACT TENSION FRACTURE TOUGHNESS SPECIMEN

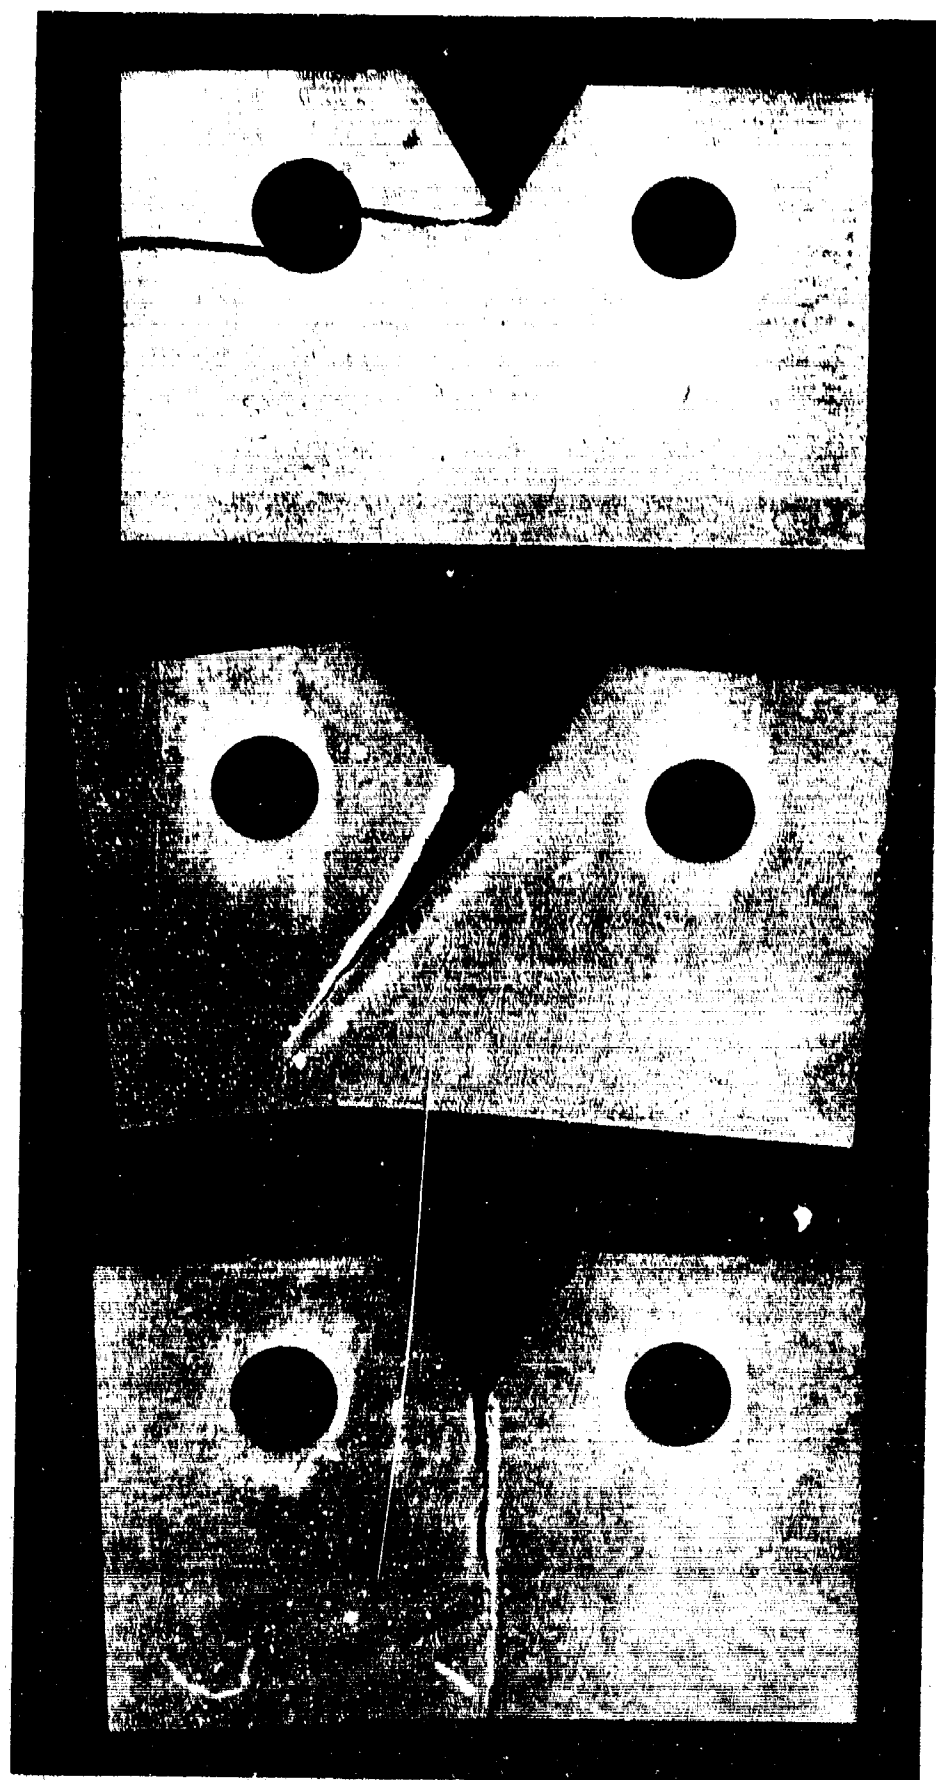
FIG. 5. FRACTURE PATHS OF TEAR SPECIMENS, SERIES 18 AND 19.

Normal

Diagonal

Pin-hole

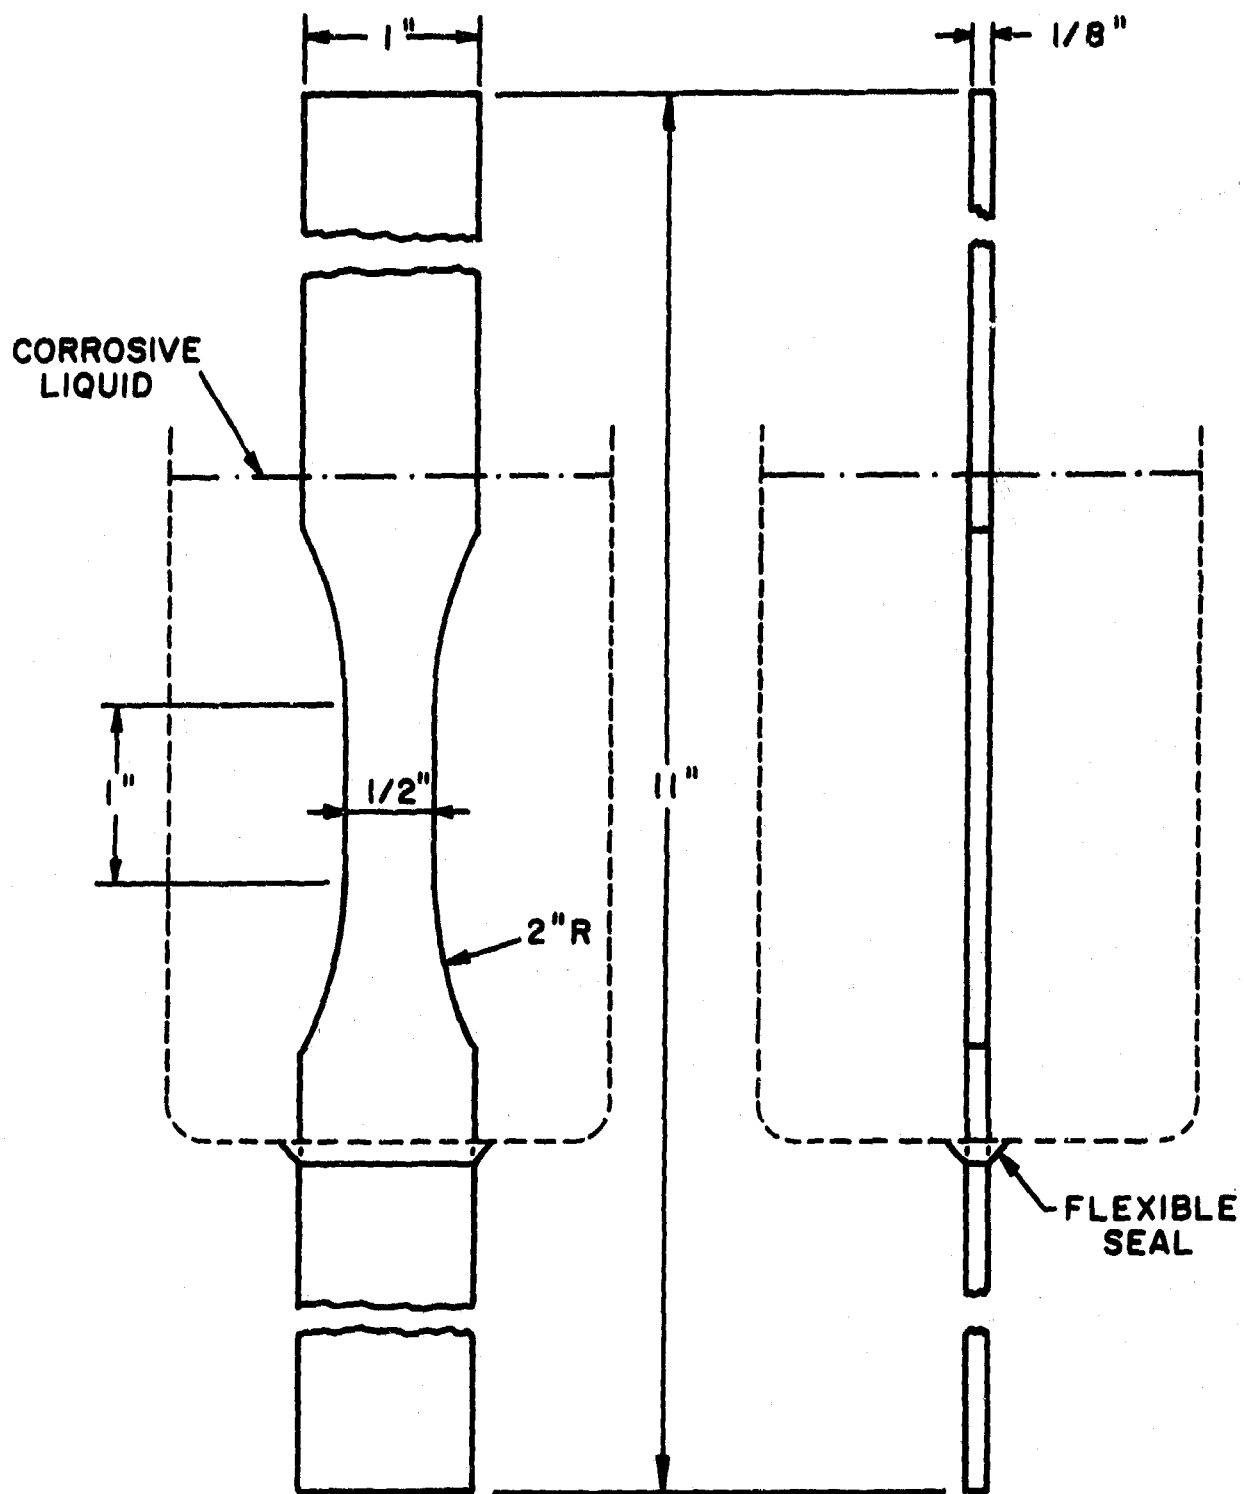
FIG. 9

AXIAL STRESS FATIGUE SPECIMEN FOR  
TESTS IN LABORATORY ATMOSPHERE  
OR SUBMERGED IN HIGHLY CORROSIVE  
LIQUID.

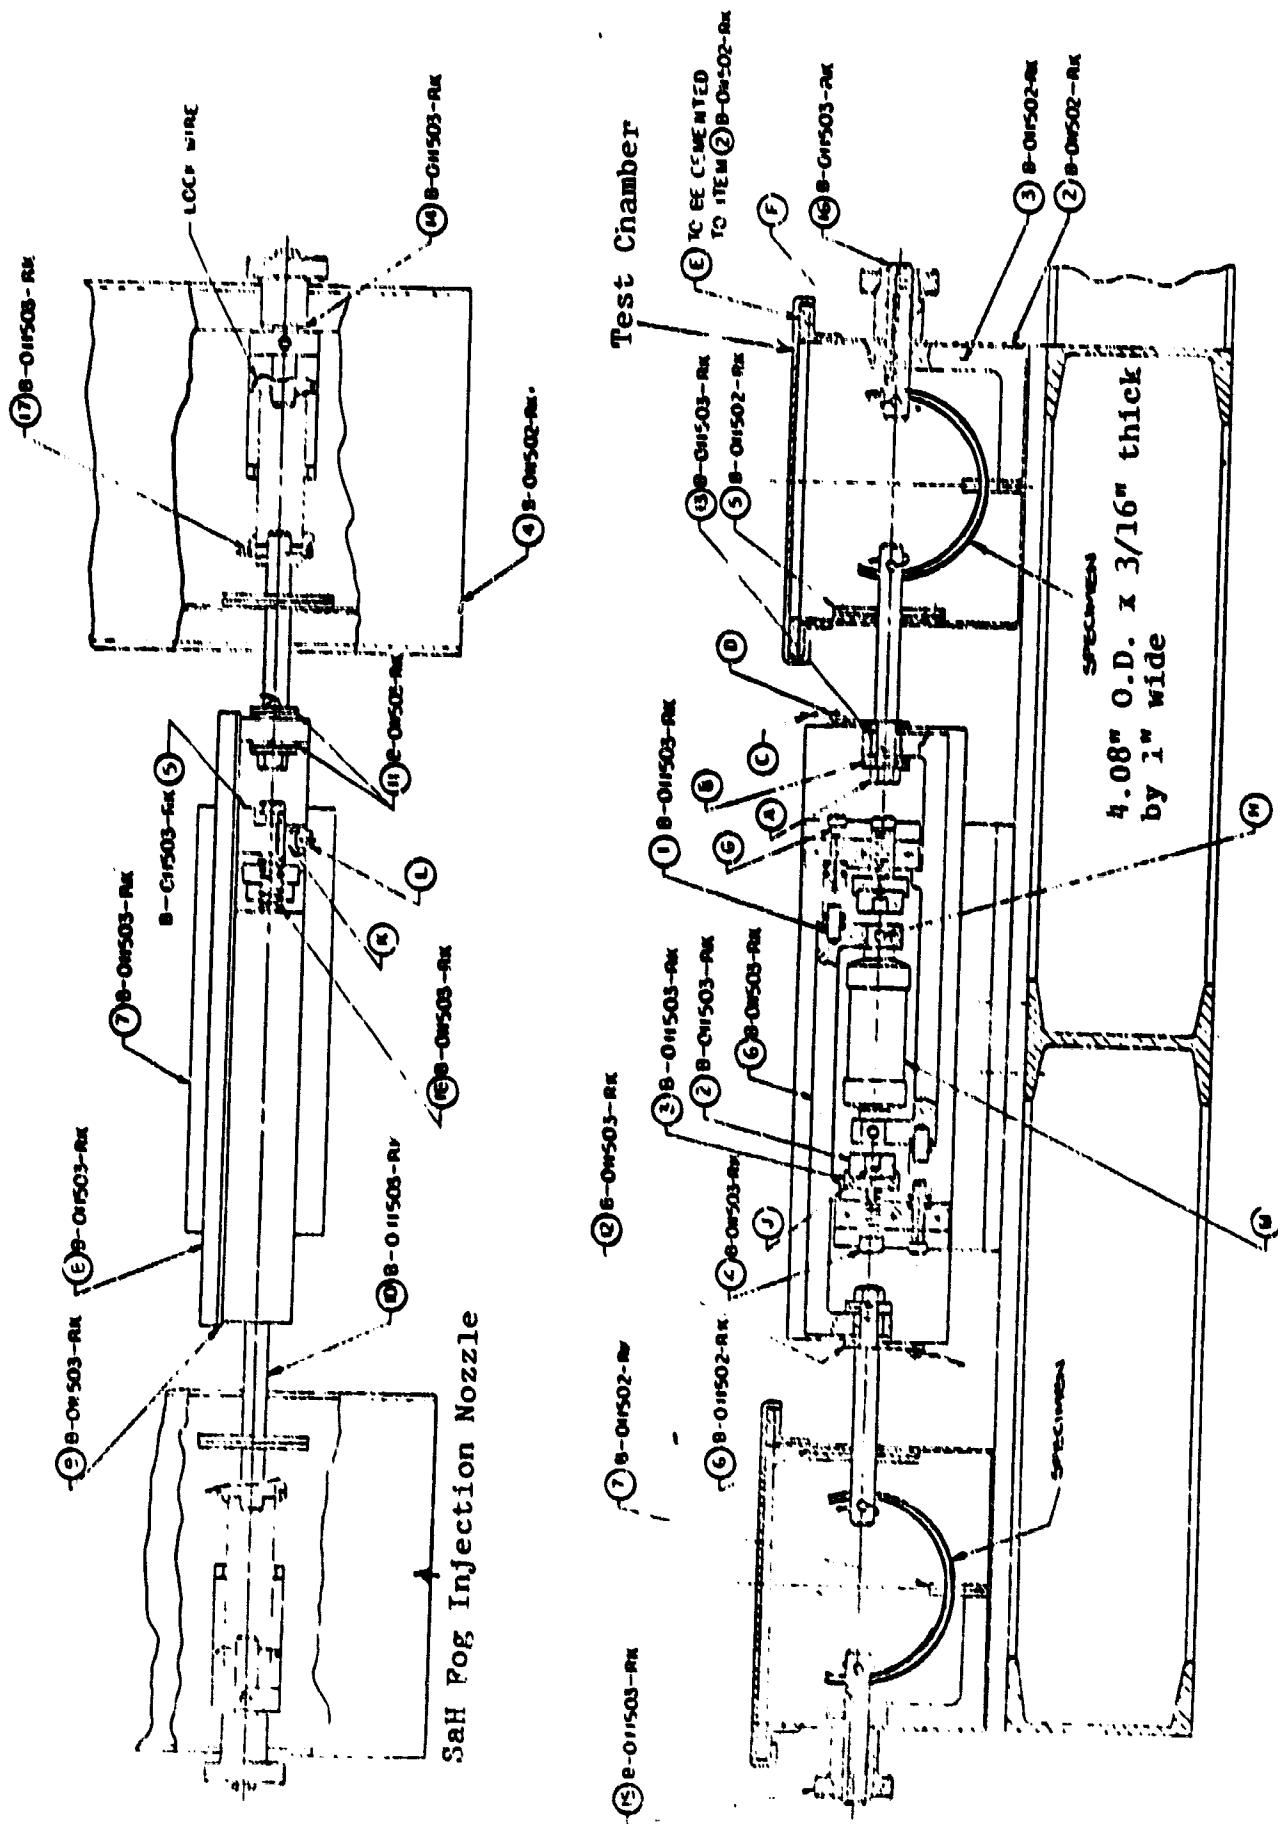
FIG. 14. APPARATUS FOR FATIGUE TESTING C-RINGS IN CONTROLLED ENVIRONMENT

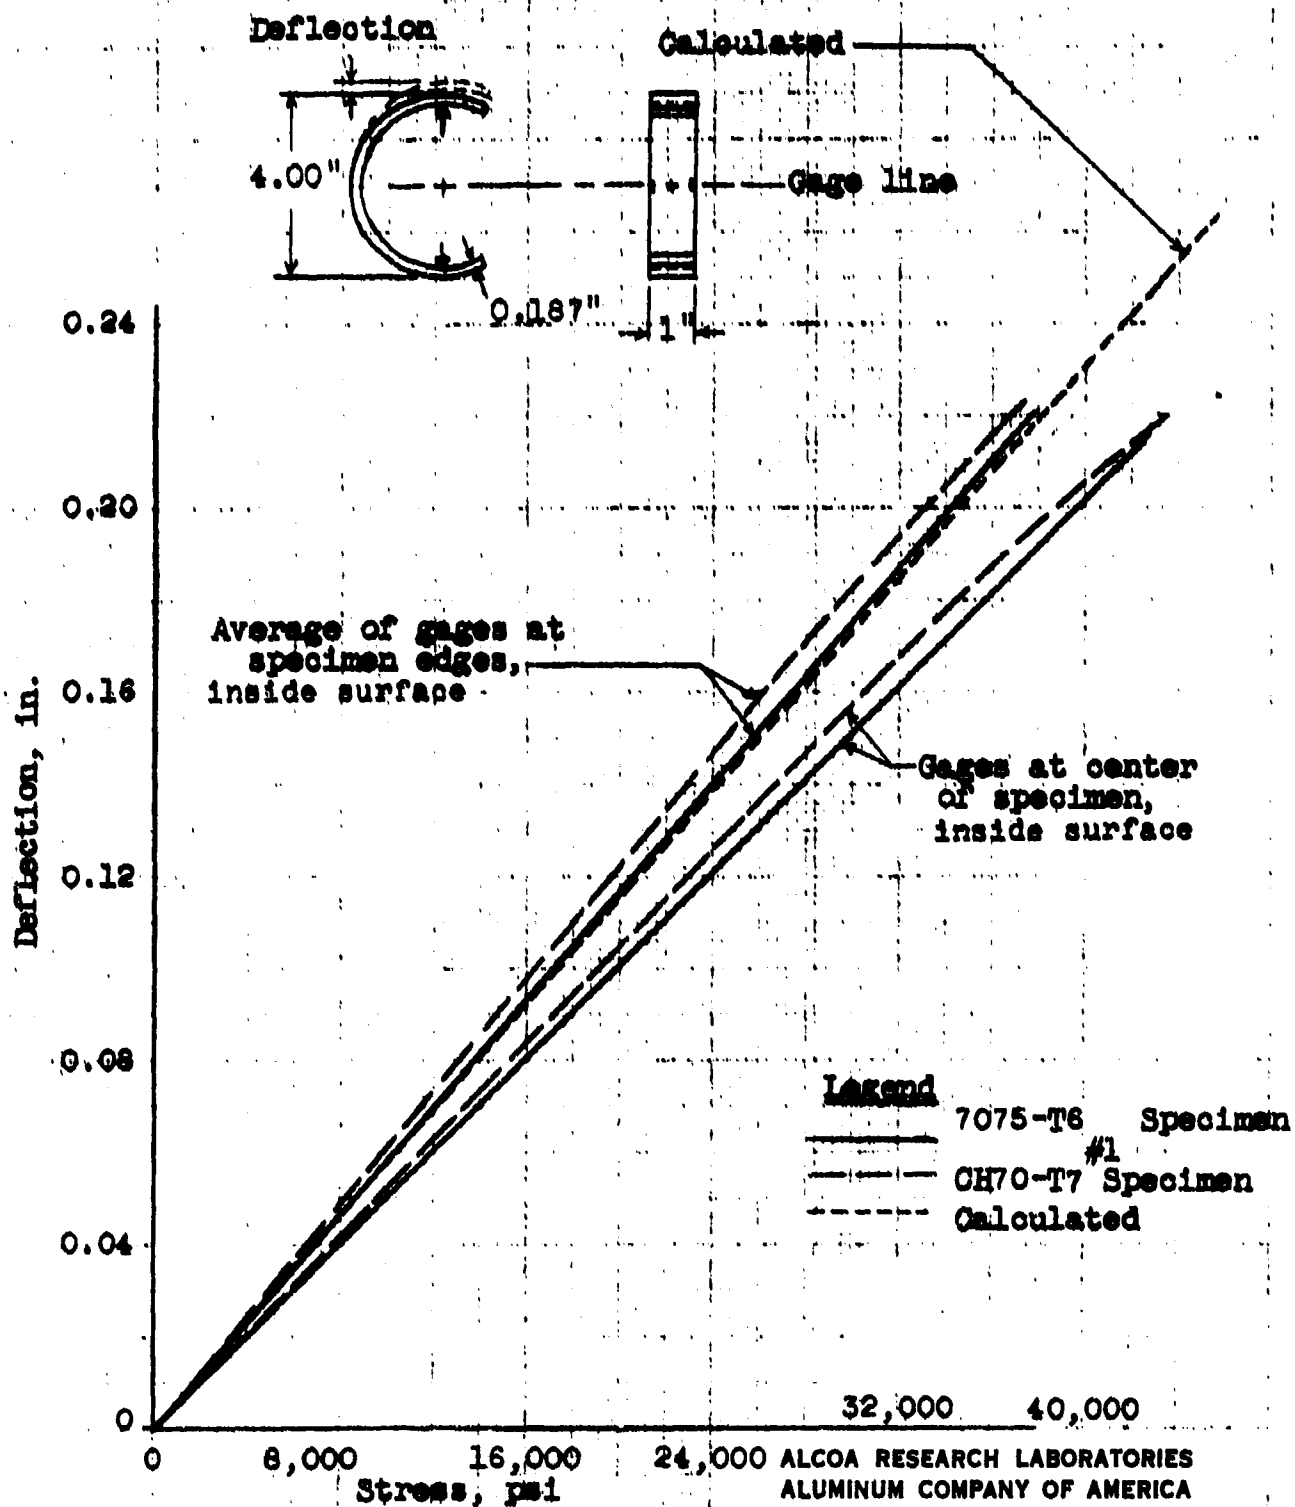
Comparison of Measured  
and Calculated Stresses  
in C-Rings

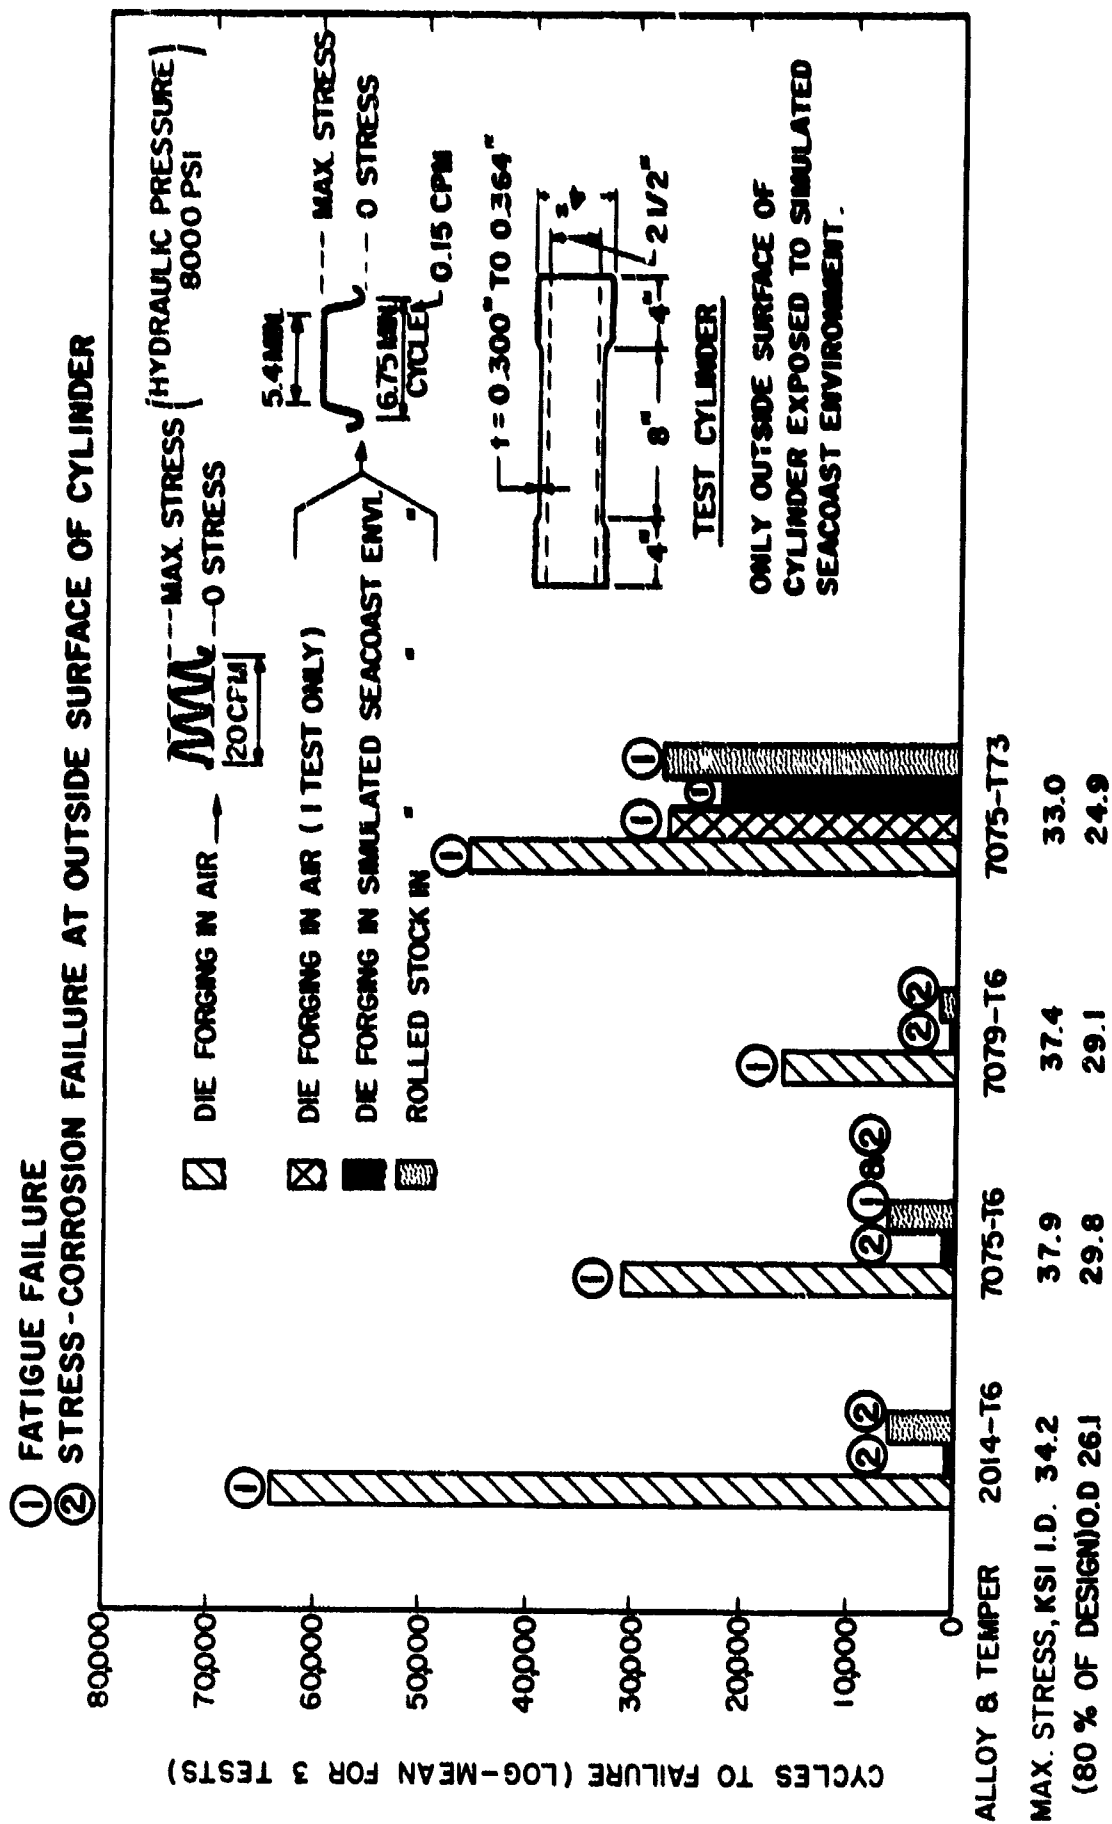
**FIG. 25a**

**EFFECT OF ENVIRONMENT ON FATIGUE LIFE OF HYDRAULIC CYLINDERS**

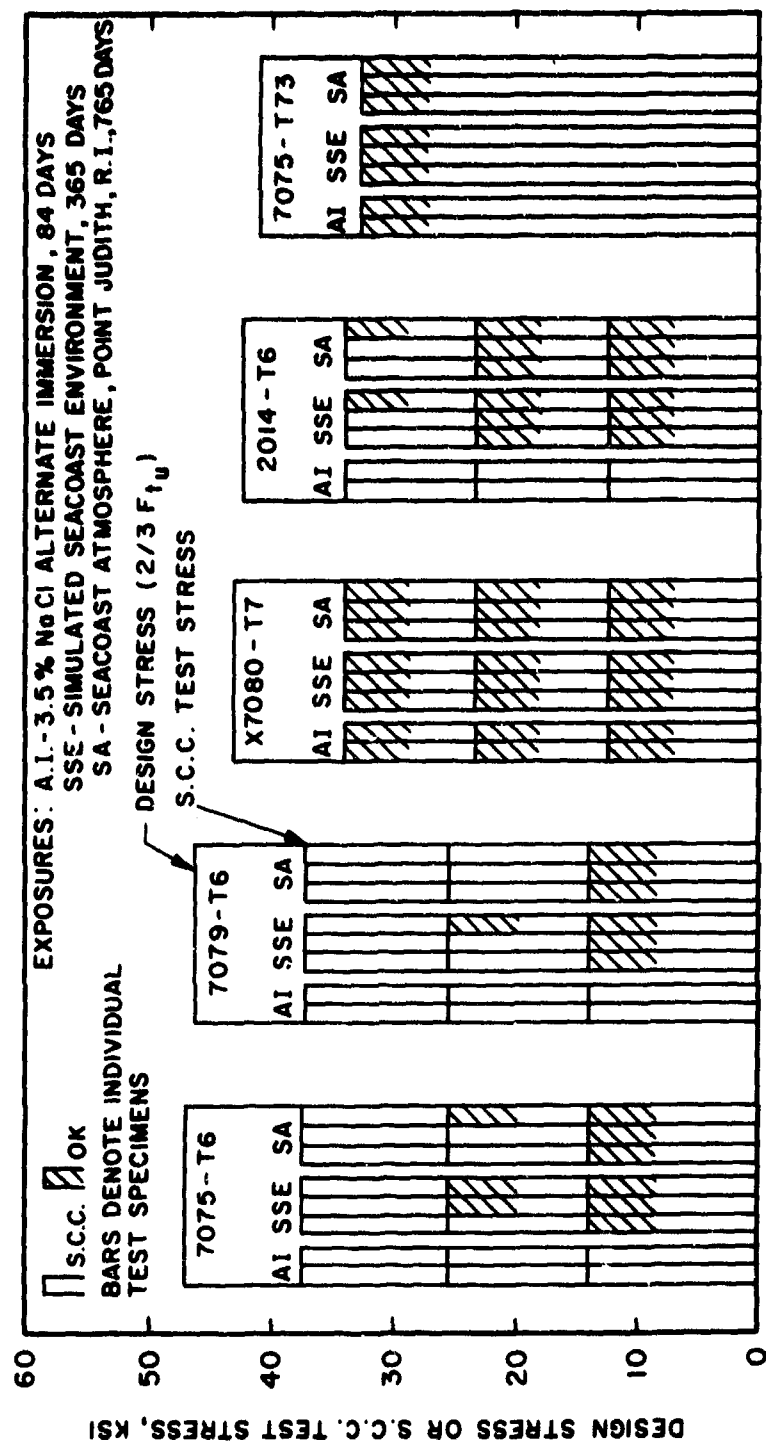
COMPARISON OF THE STRESS-CORROSION PERFORMANCE OF STATIC-LOADED C-RINGS FROM THE ROLLED ROD STOCK IN THREE CORROSIVE ENVIRONMENTS.

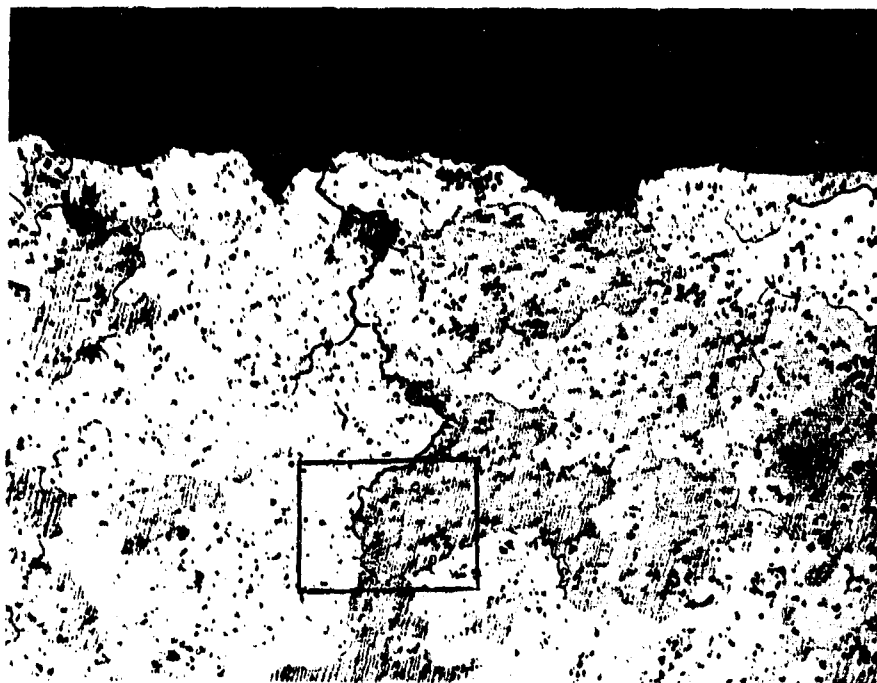
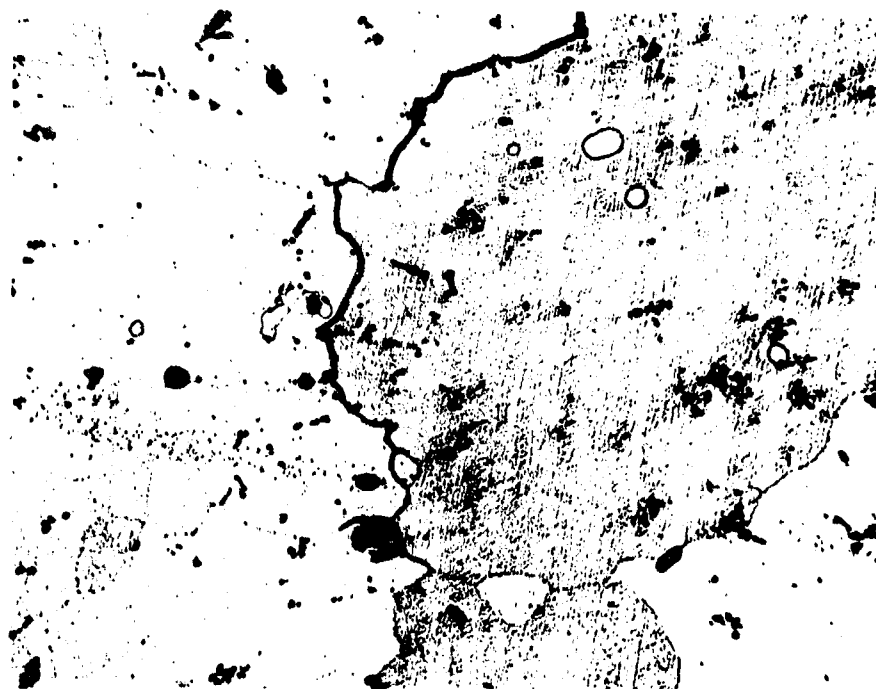
- a Cross-section through C-ring from 2014-T6 rod stock, stressed to 80% of design stress after 44 days' exposure to alternate immersion. Many short stress corrosion cracks of the type illustrated were found. (X100)

- b Higher magnification of region outlined above more clearly showing the intergranular nature of the cracking, which is typical of stress-corrosion cracking in aluminum alloys. (X500)

STATIC STRESS-CORROSION CRACKING OF C-RING FROM 2014-T6 ROLLED ROD STOCK IN ALTERNATE IMMERSION TEST

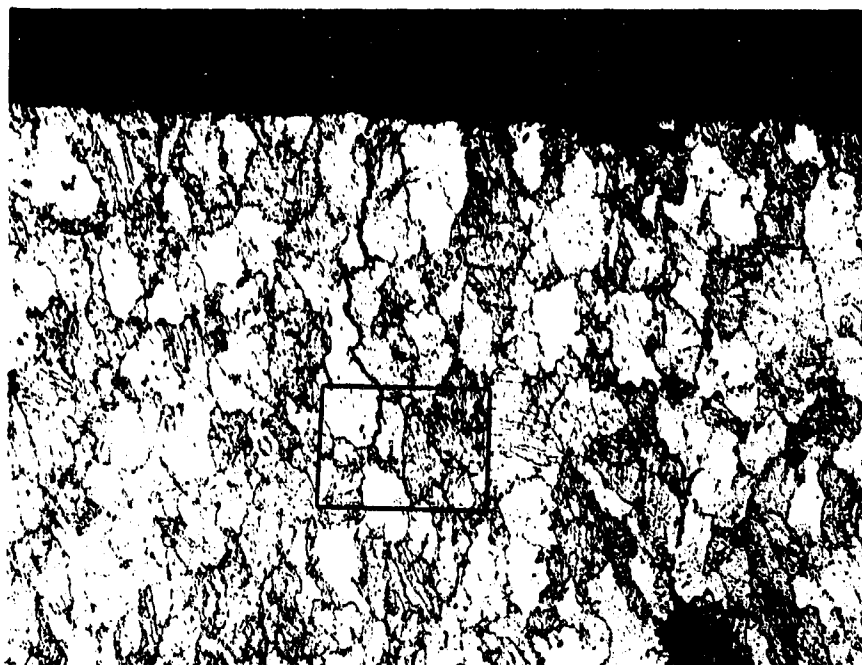
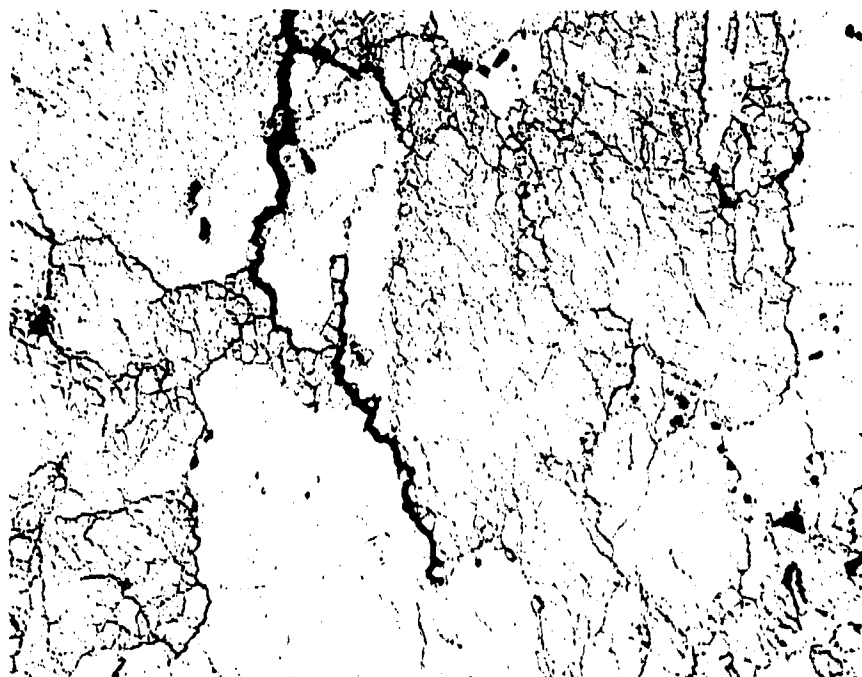
- a Cross-section through C-ring from 7075-T6 rod stock, stressed to 80% of design stress after 44 days' exposure to alternate immersion. Many short stress corrosion cracks of the type illustrated were found. (X100)

- b Higher magnification of region outlined above more clearly showing the intergranular nature of the cracking, which is typical of stress-corrosion cracking in aluminum alloys. (X500)

STATIC STRESS-CORROSION CRACKING OF C-RING FROM 7075-T6 ROLLED ROD STOCK IN ALTERNATE IMMERSION TEST

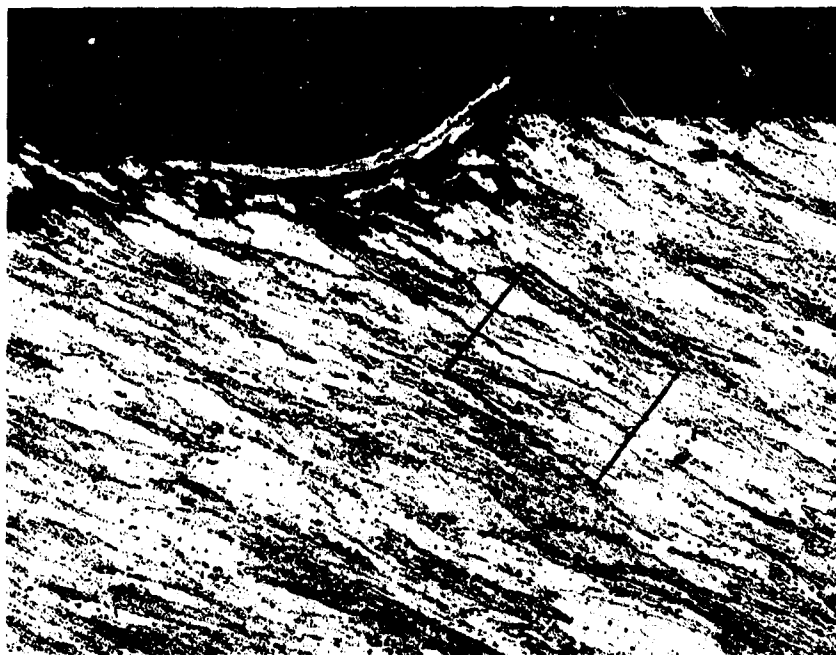
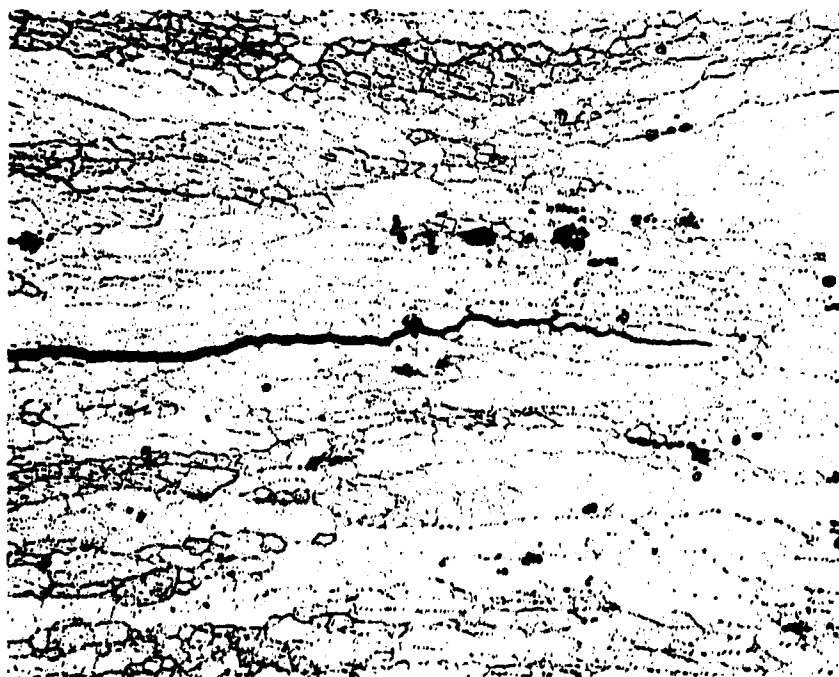
Fig. 31

Cross-section through one of the C-rings from 7075-T6 die forging stressed to 30% design stress after 293 days' exposure to the simulated seacoast environment. These rings were removed from test because of exfoliation in the test region but microscopic examination showed small stress corrosion cracks were also present. (X100)

Higher magnification of region outlined above showing the crack is following an intergranular path, which is typical of stress-corrosion cracking in aluminum alloys. (X500)

STATIC STRESS-CORROSION CRACKING OF C-RING FROM 7075-T6 FORGING  
IN SIMULATED SEACOAST ENVIRONMENT

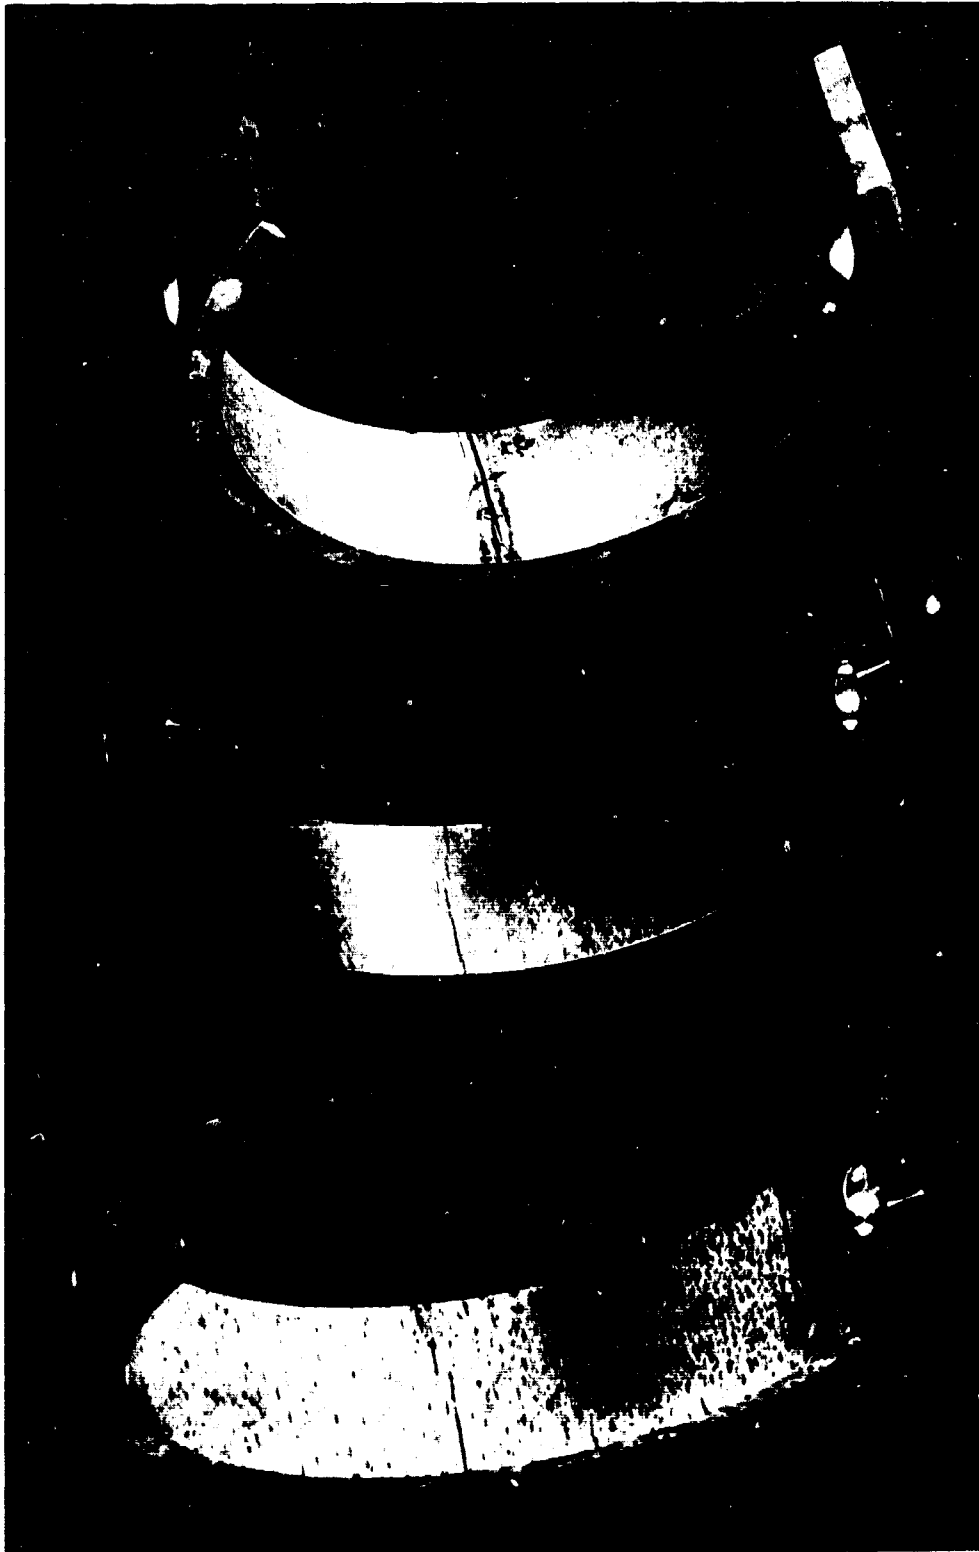
Illustrates appearance of three C-rings from the 7075-T6 forging after exposure to 3.5% NaCl - alternate immersion, simulated seacoast environment and seacoast atmosphere at a stress of 55% design stress. Note that the corrosivity of the simulated seacoast environment is similar to the actual seacoast atmosphere causing a general roughening of the surface. In contrast, the alternate immersion test is more corrosive and develops discrete pits.

FIG. 32. TYPICAL STRESS-CORROSION FAILURES OF STATICALLY LOADED C-RINGS

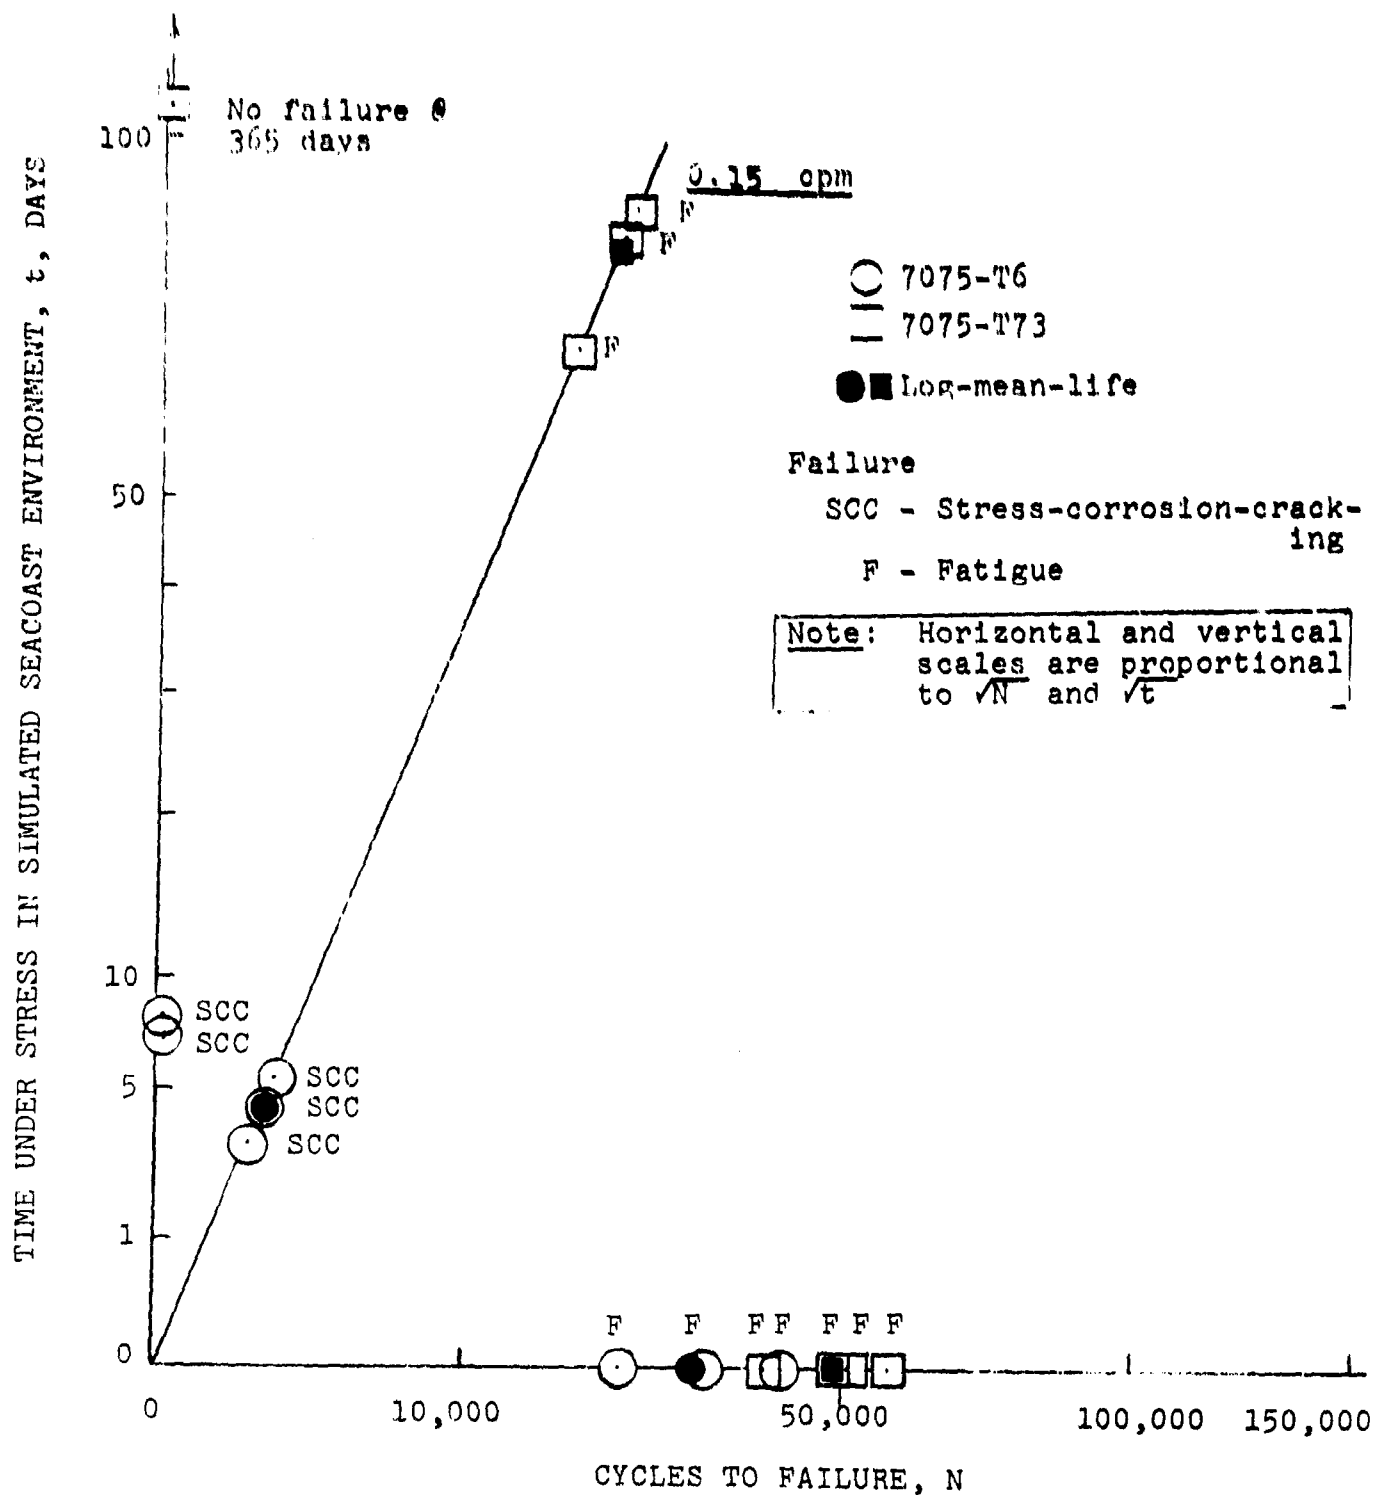
STRESS-CORROSION-FATIGUE TESTS OF 7075-T6 AND 7075-T73 CYLINDERS

Maximum Stress = 80% of Design

TIME UNDER STRESS IN SIMULATED SEACOAST ENVIRONMENT, t, DAYS

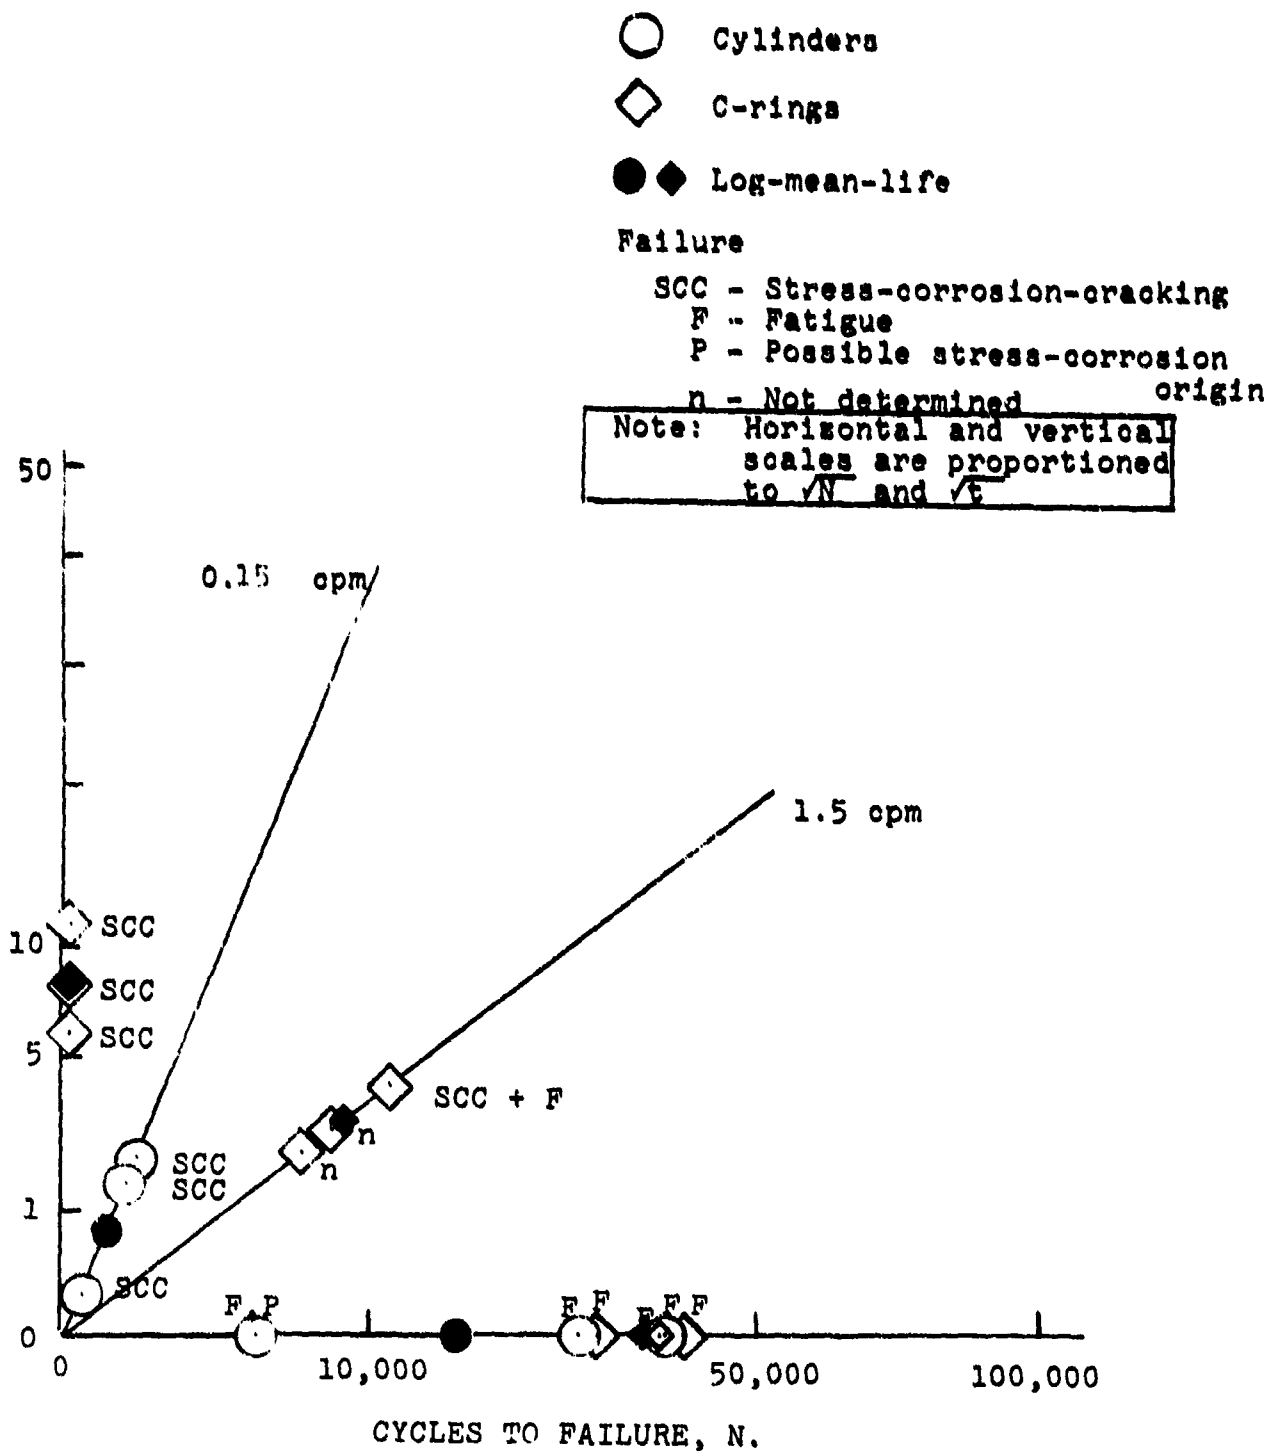
STRESS-CORROSION-FATIGUE TESTS OF 7079-T6 CYLINDERS AND C-RINGS  
Maximum Stress = 80% of Design
